**Whitesand First Nation  
Cogeneration and Pellet Mill Project**

**Water Assessment Report**

**Sagatay Cogeneration LP**

**October 2014**

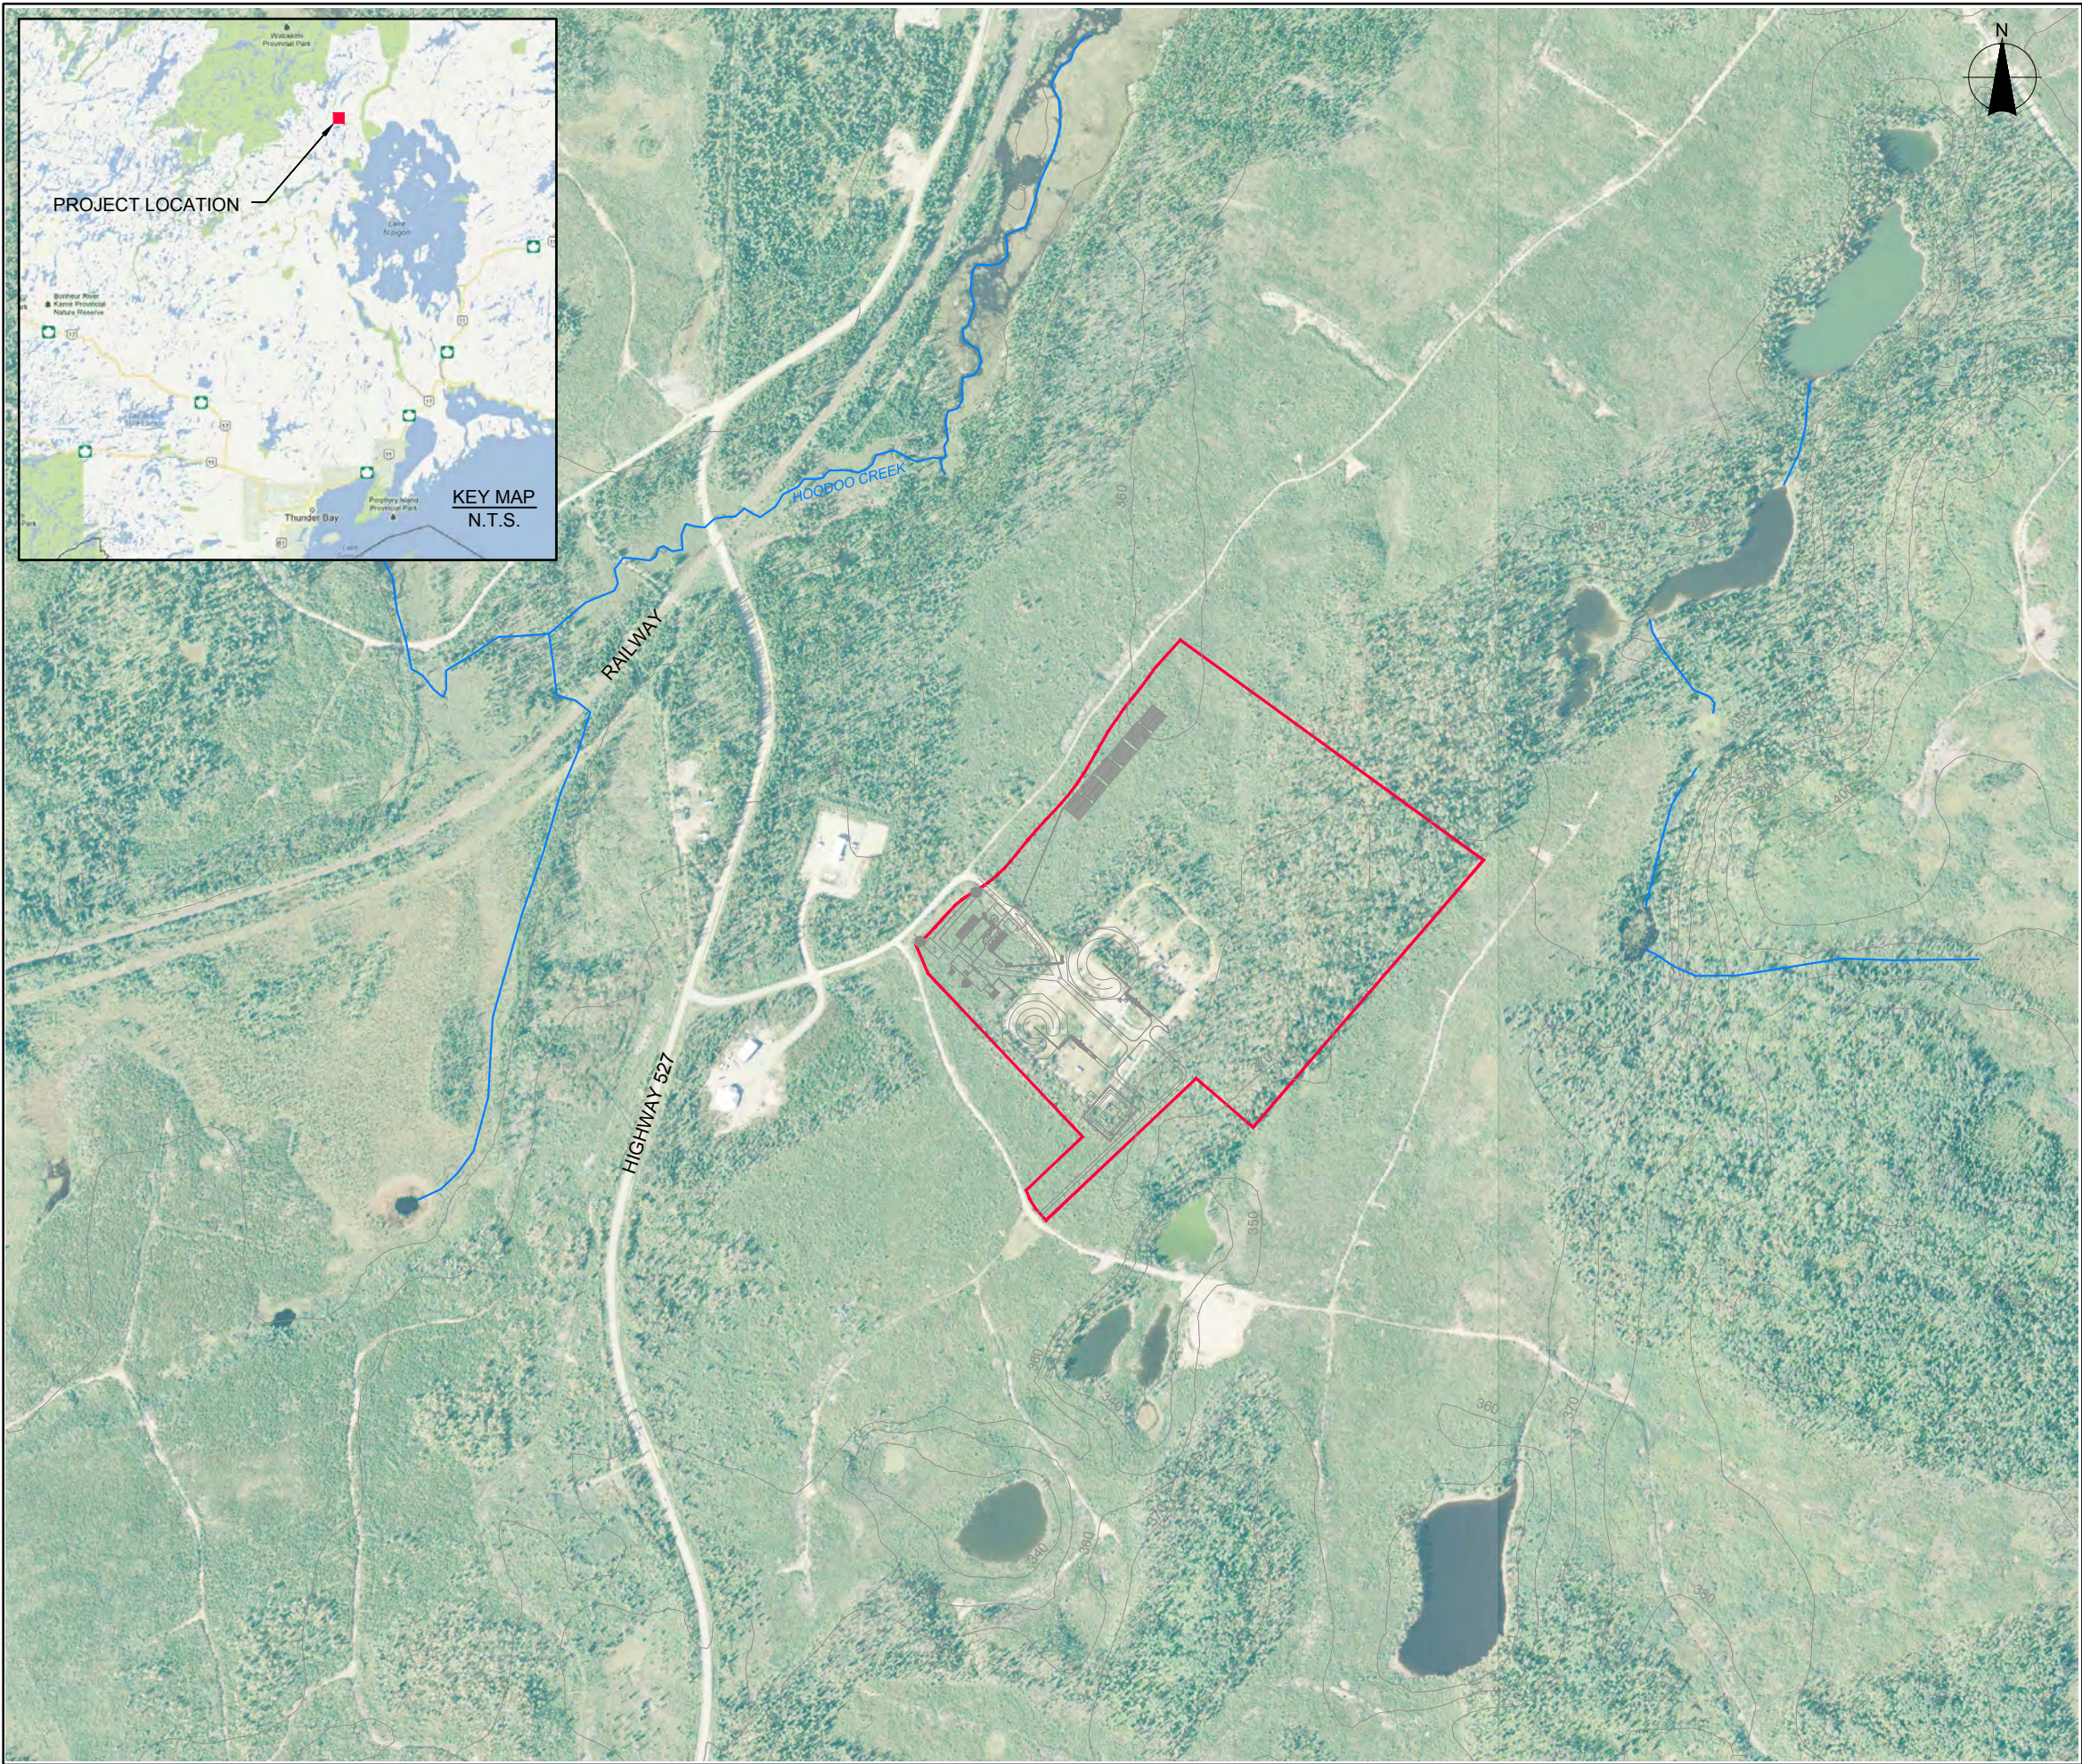
FIGURE A1

WHITESAND FIRST NATION  
COGENERATION & PELLET MILL PROJECT  
*RENEWABLE ENERGY APPROVAL*  
*WATER ASSESSMENT REPORT*

Sagatay Cogeneration LP, with its General Partner, Sagatay Cogeneration Ltd., and Whitesand First Nation ("Whitesand") as agent is proposing to develop, construct and operate a biomass fueled electric power and heat cogeneration plant, and wood pellet facility (the "Project"). The Project is located in an unorganized territory of the Thunder Bay District near Whitesand First Nation and Armstrong, Ontario. The unorganized territory is administered by the Armstrong Local Service Board and the Project will be located on Crown Land in the traditional territory of Whitesand First Nation, as shown on **Figure A1 of Appendix A.**

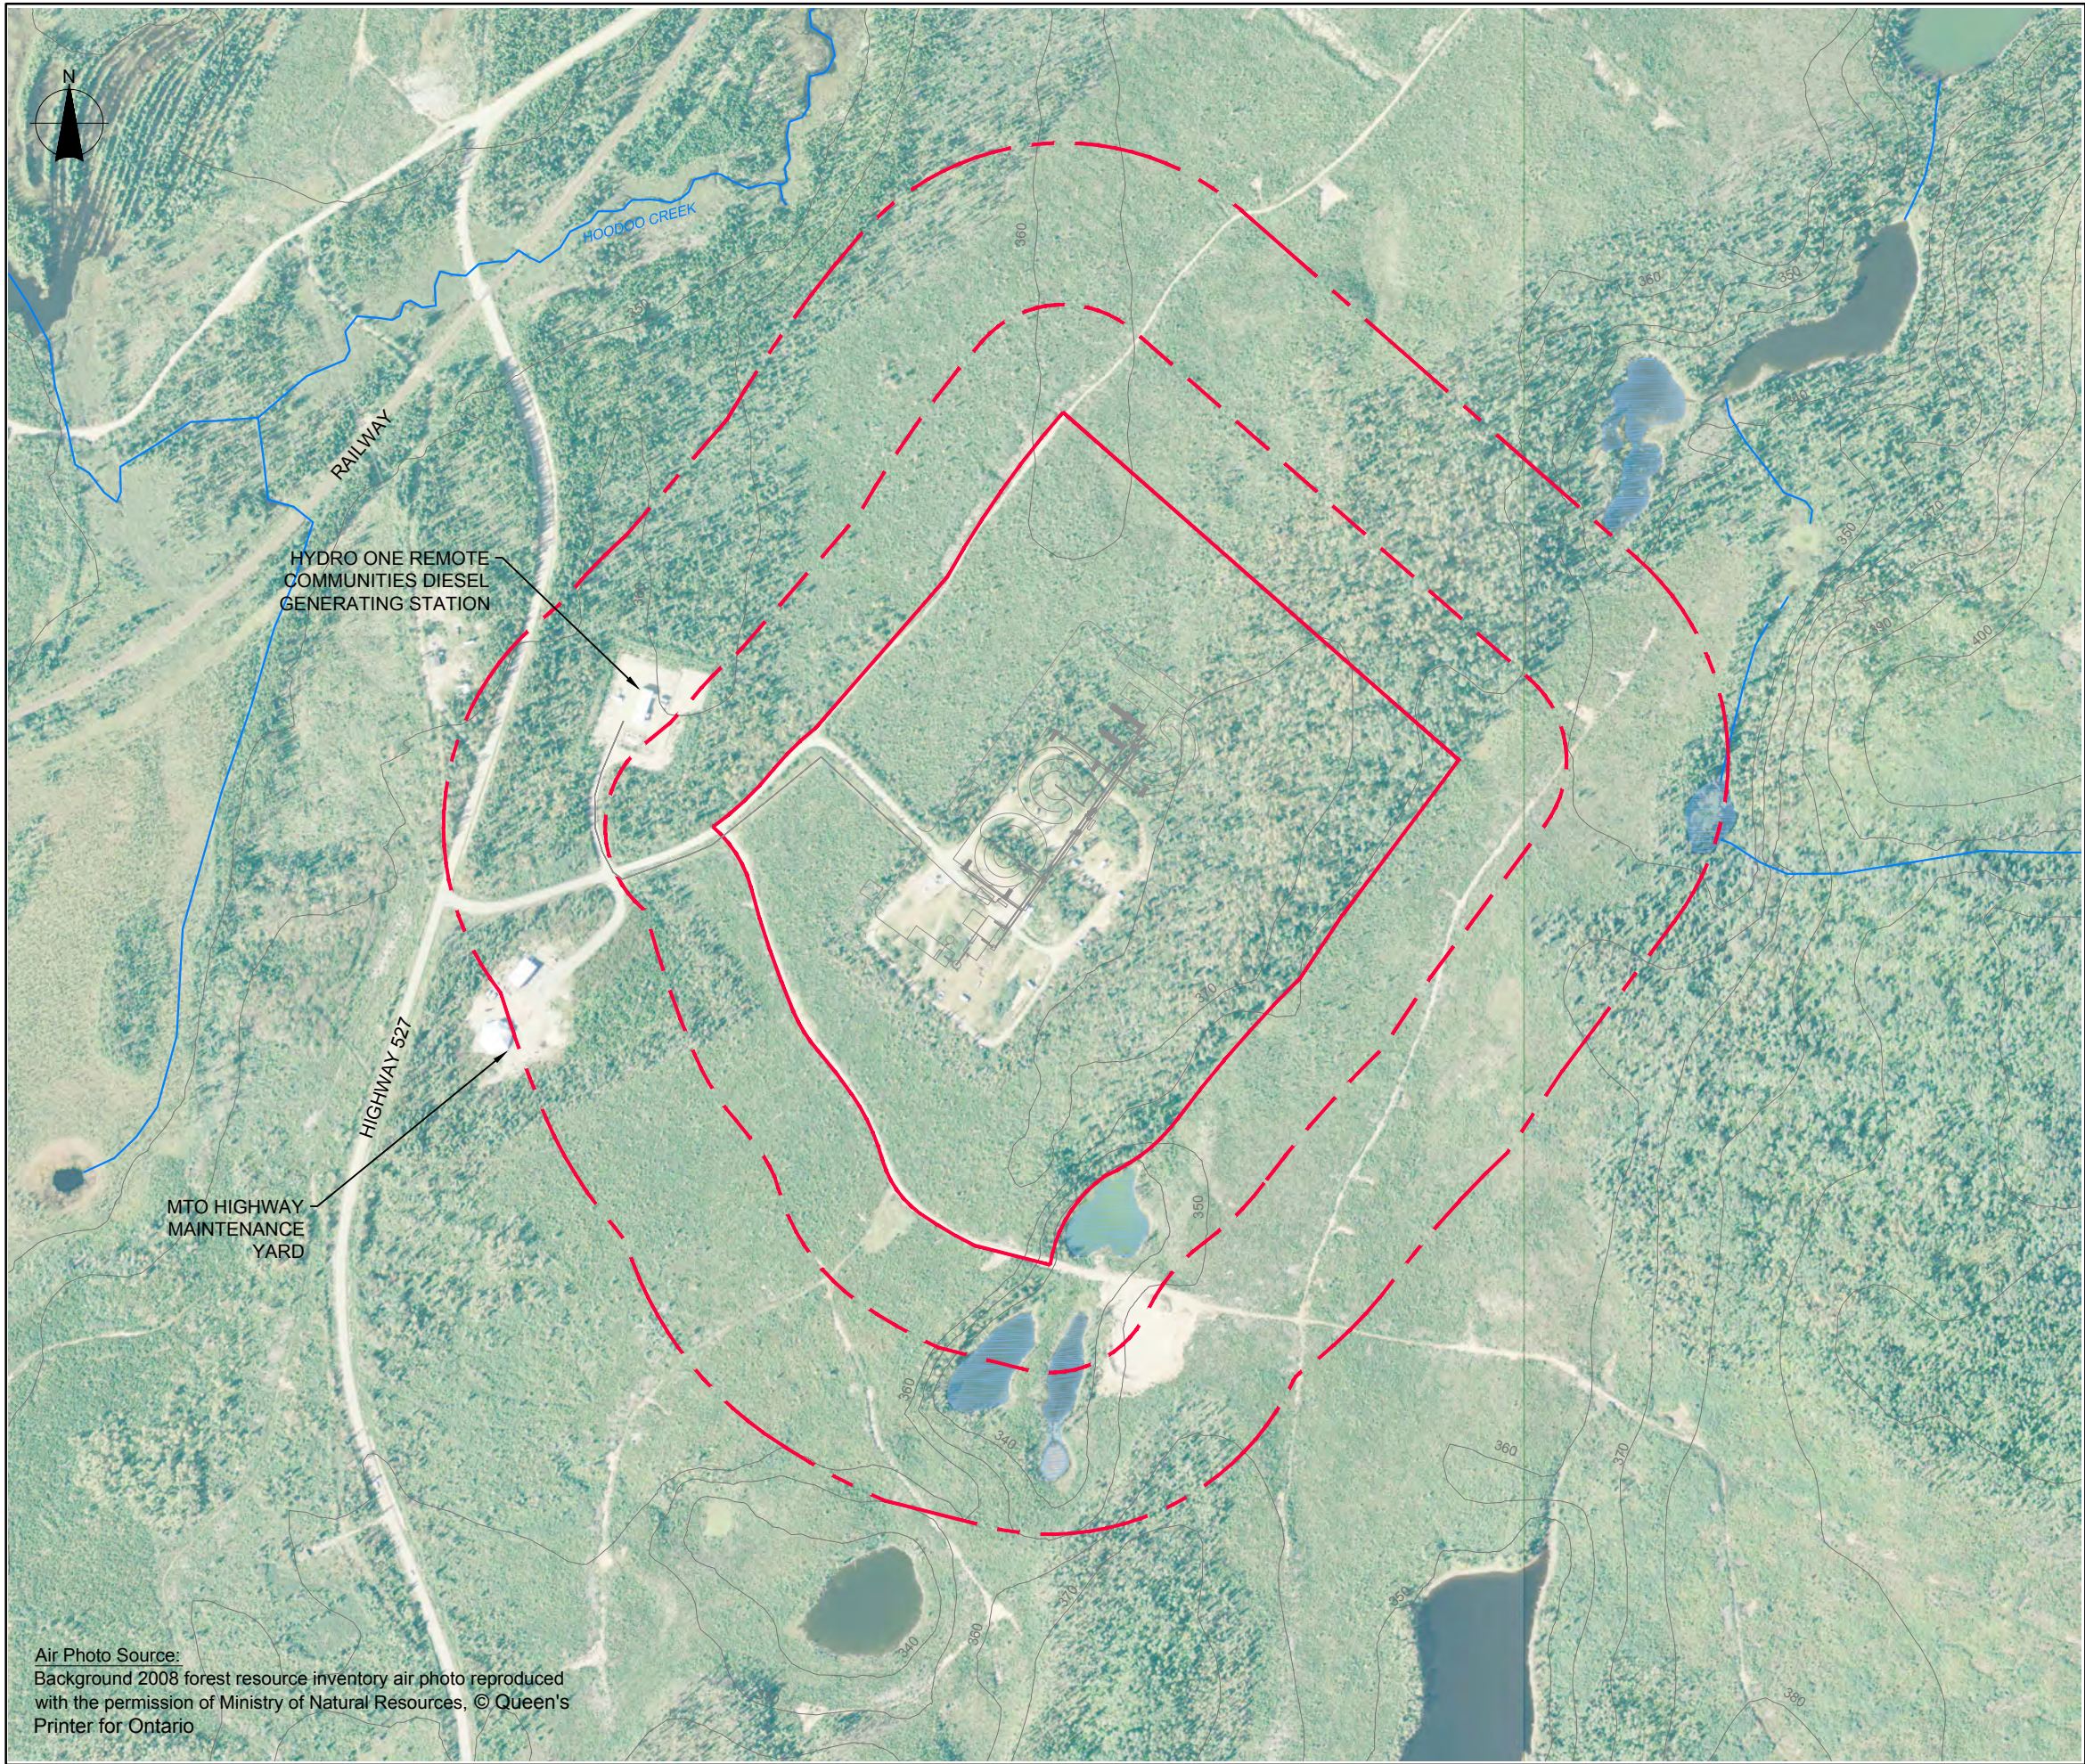
FIGURE A2

WHITESAND FIRST NATION  
COGENERATION & PELLET MILL PROJECT  
*RENEWABLE ENERGY APPROVAL*  
WATER ASSESSMENT REPORT
