**Whitesand First Nation
Cogeneration and Pellet Mill Project
Hydrogeological Assessment**

Neegan Burnside Ltd.
292 Speedvale Avenue West Unit 20 Guelph ON N1H 1C4

October 2014

File No: 300030895.0000

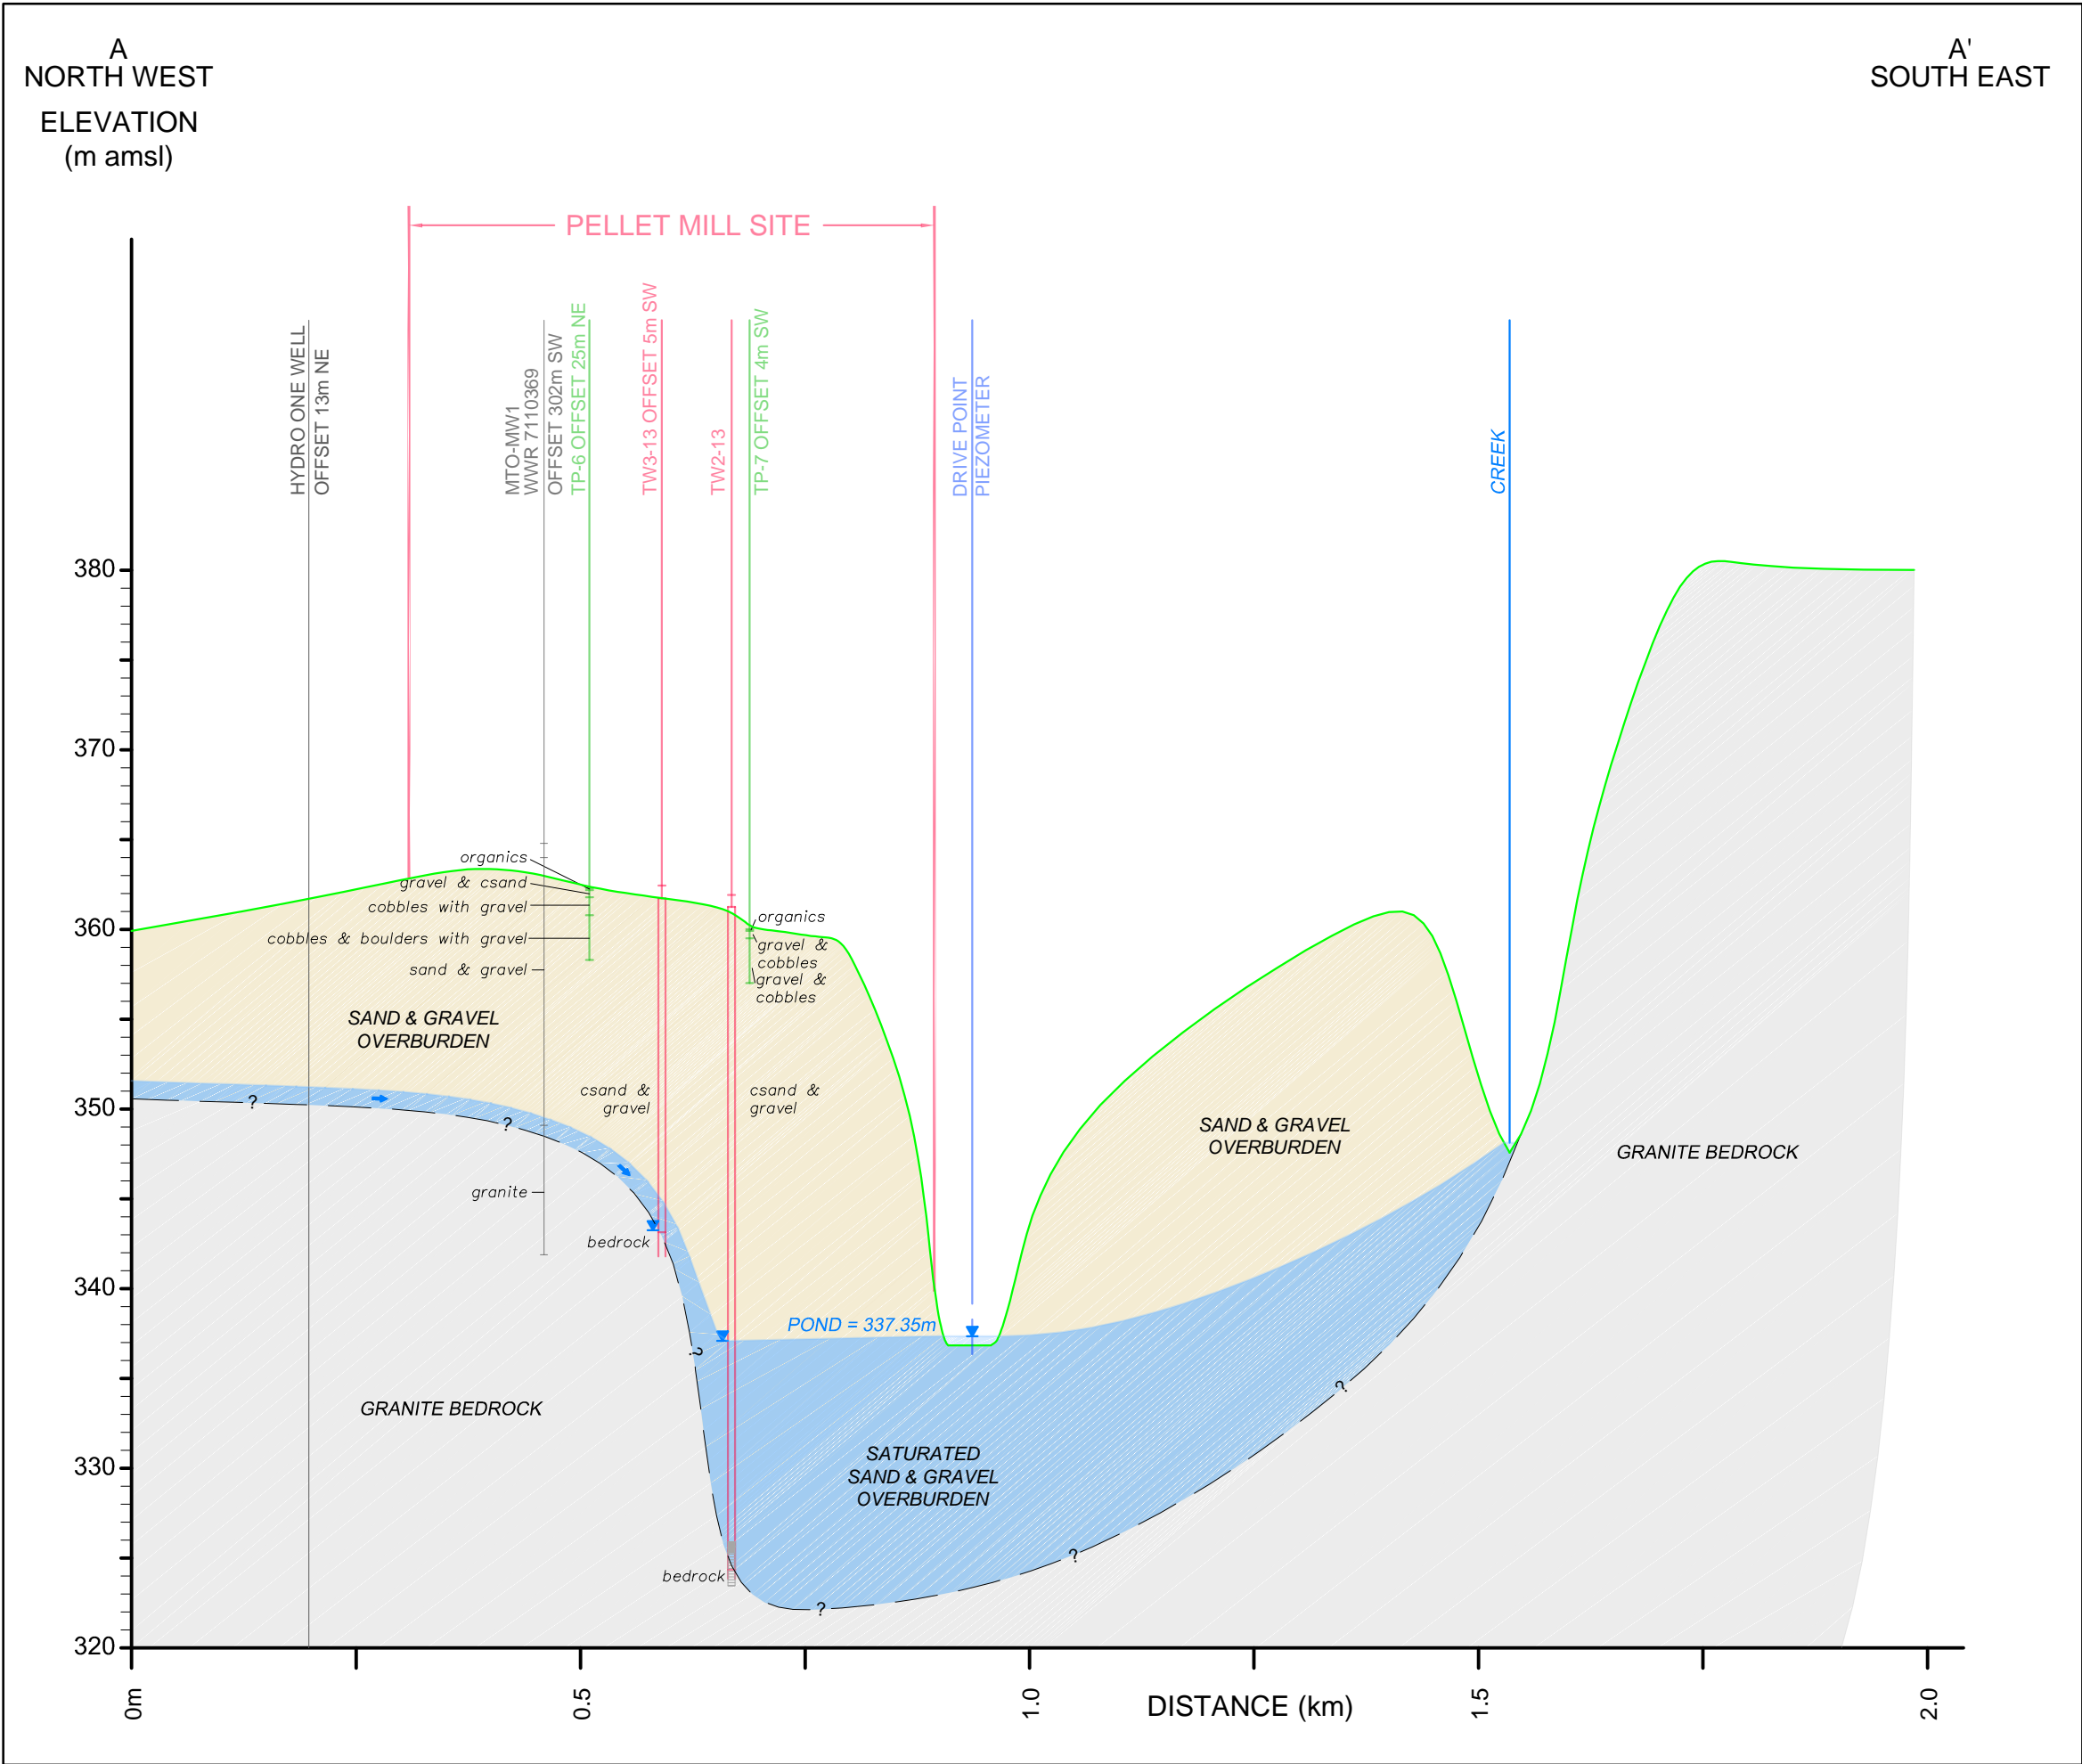
FIGURE 5
WHITESAND FIRST NATION
COGENERATION & PELLET MILL PROJECT
HYDROGEOLOGICAL ASSESSMENT REPORT

CROSS-SECTION A-A'

Figure 4 includes bedrock elevation data from the Armstrong Groundwater Management and Protection Study (Burnside, 2005). This figure shows that the bedrock elevation virtually mirrors the surface elevation; with bedrock highs occurring in the regions of high elevations and correspondingly lower in the regions of topographical lows. This indicates that a bedrock valley feature is present in the area of Armstrong as described above. The depth to bedrock is shown in Figure 5 using the geologic descriptions from the wells drilled on-site. This cross section indicates a defined bedrock valley in the area of TW2-13.

The overburden is considered an unconfined aquifer that exhibits a relatively high hydraulic conductivity and relatively high infiltration rates. The water level in TW2-13 is similar to that in the pond south of the site (**Figure 5 and 7**). It is interpreted that the ponds to the south of TW2-13 are surface expressions of the groundwater present in the sand and gravel above the bedrock.
