<b>NEEGAN BURNSIDE</b>		Map Title Environmental Survey Field Map	
Client Whitesands First Nation	Drawn P.S.	Checked N/A	Date 2013/08/15
	Scale 1:5,000	Project No. 300030895	Map No. 1/1

WFW Pellet-mill / Co-gen Site Visit - Day 1

WFN Pellet mill / Co-gen Site Visit - Day 2

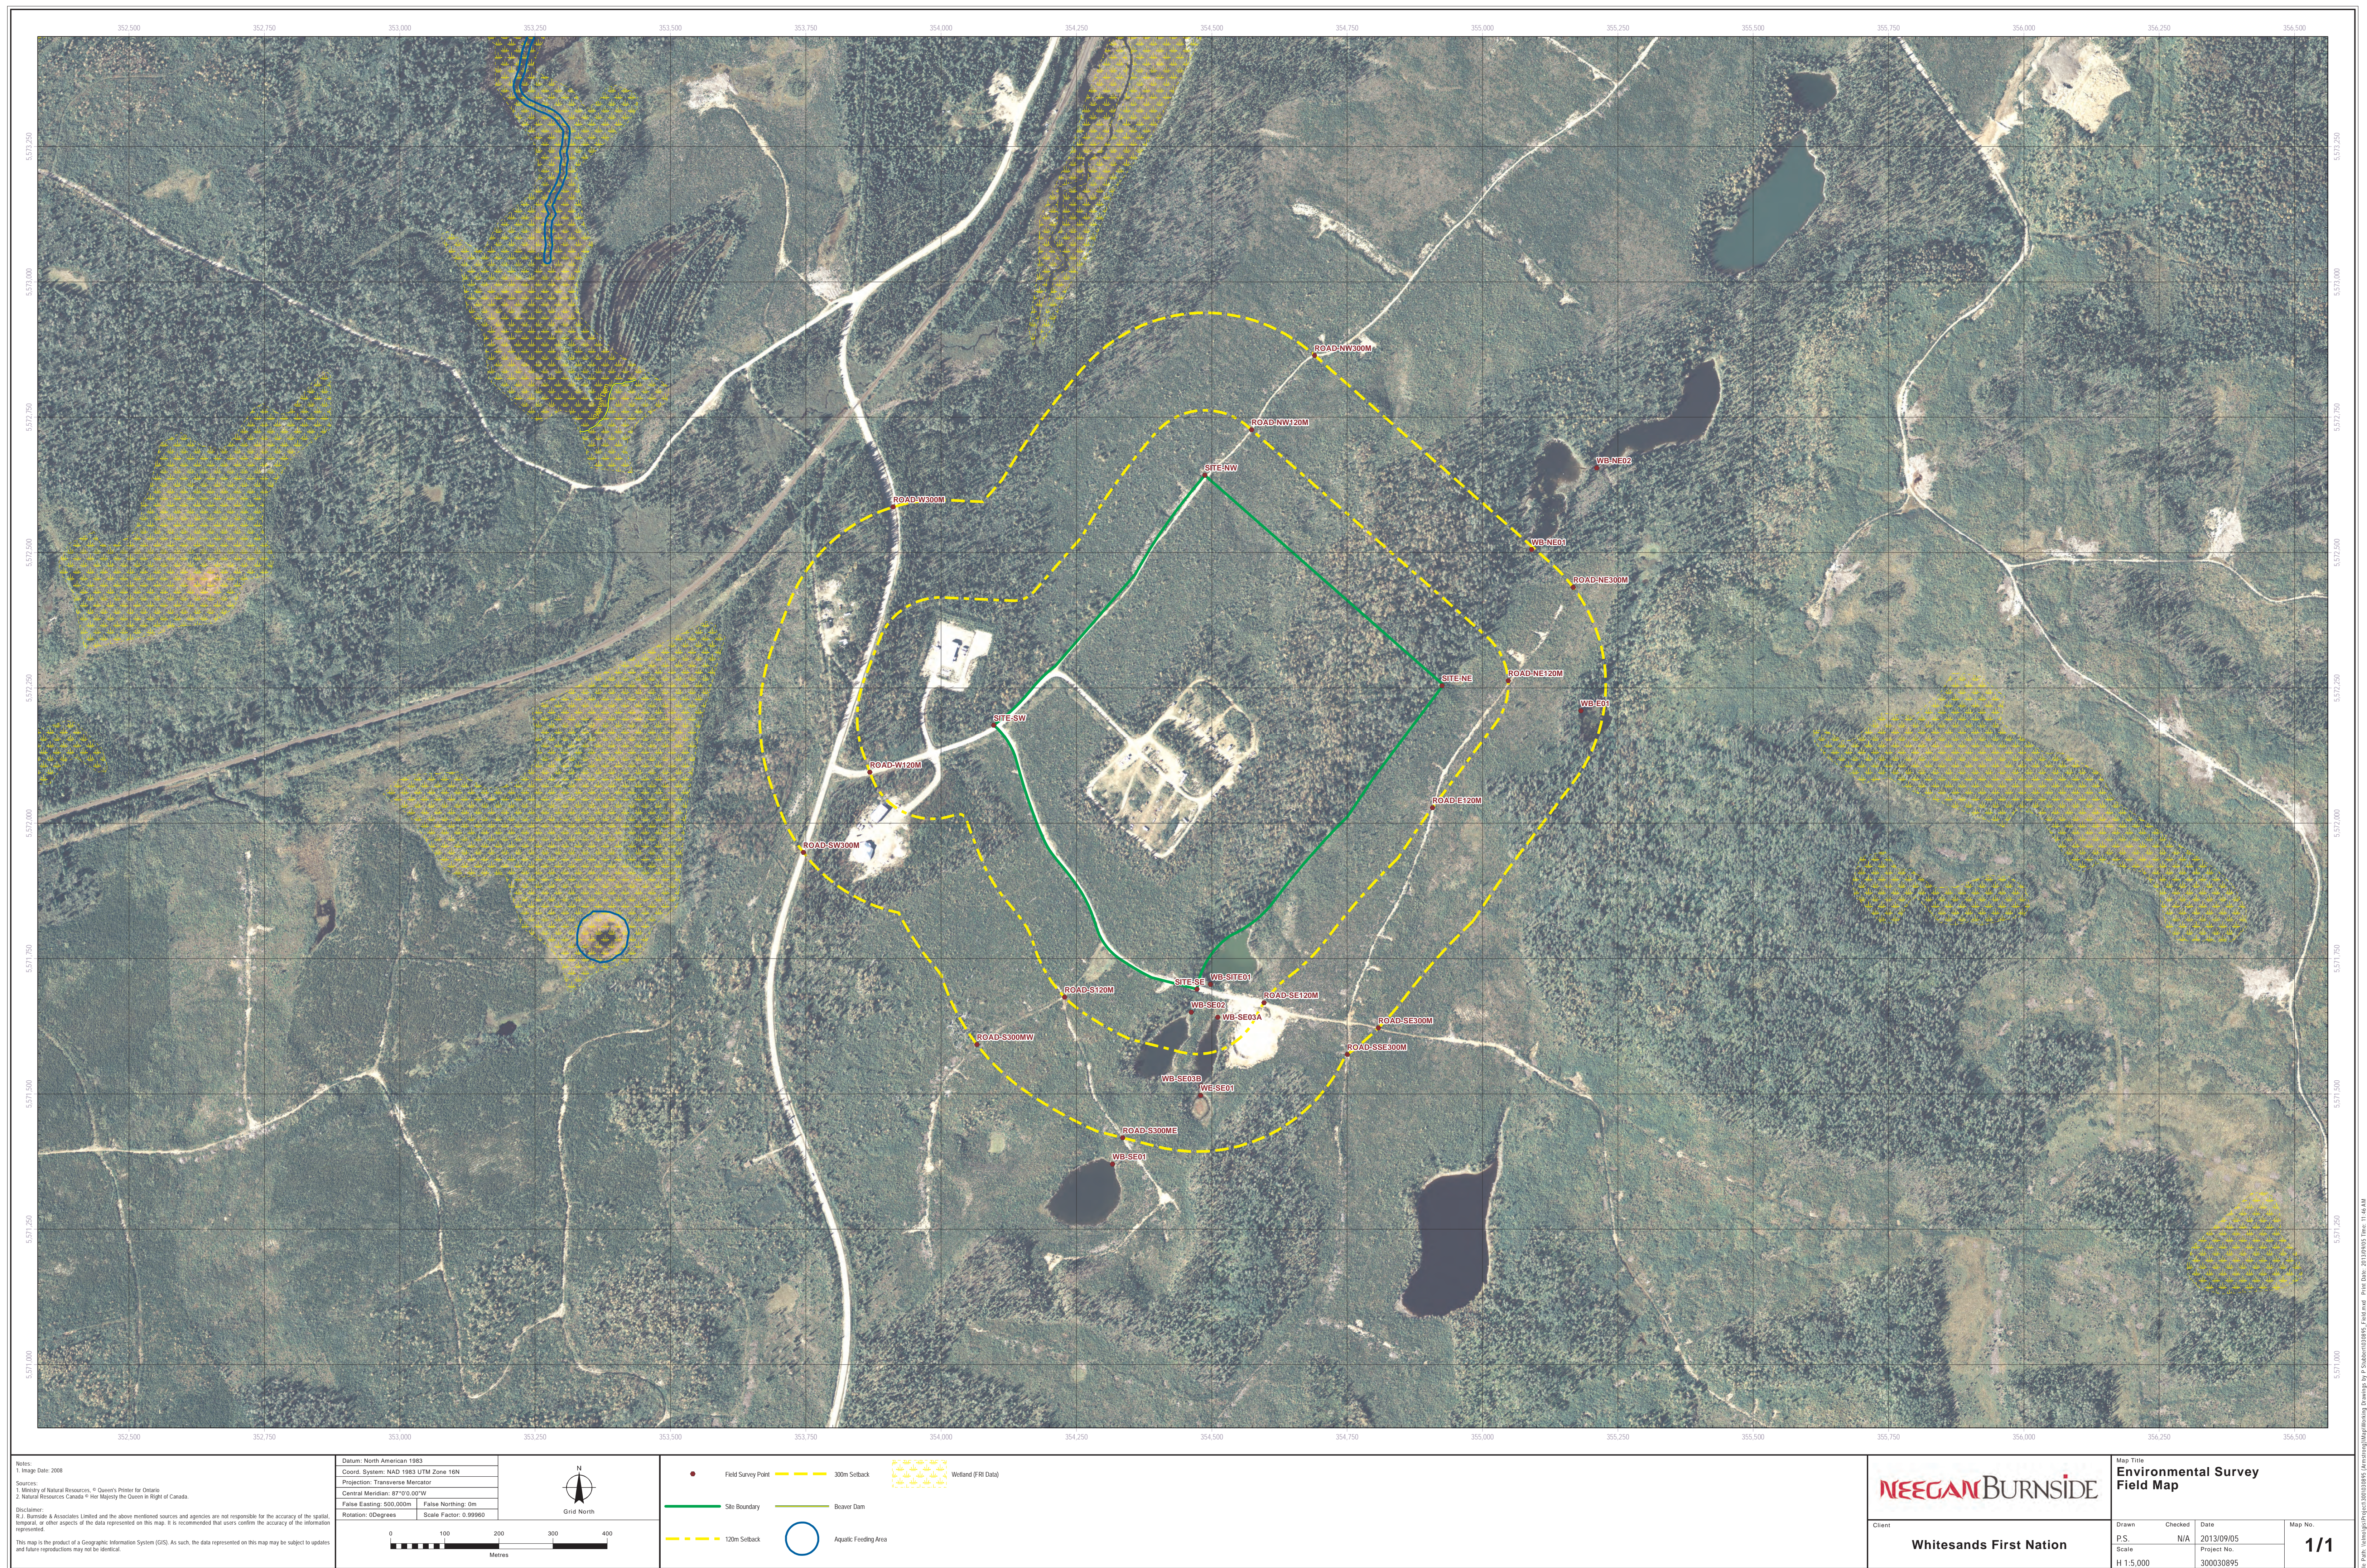
# Field Map for DEVANS OBS.

• Field_Survey_Points	300m Setback	Wetland (FRI Data)
Site Boundary	Beaver Dam	
120m Setback	Aquatic Feeding Area
